XXVII Jornada de Diagnòstic Prenatal Ecogràfic

Malformació del si dural

Hospital Universitari Son Espases

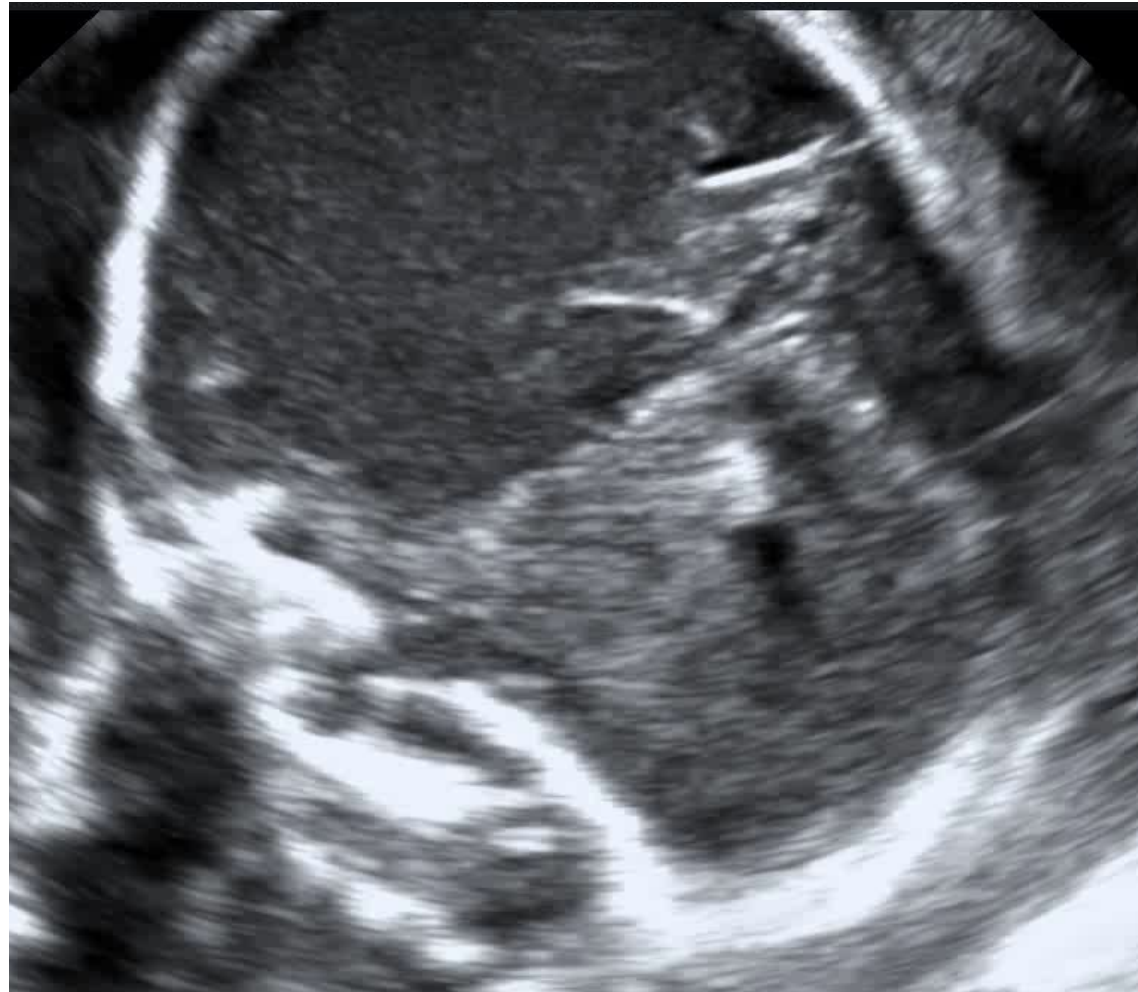
No es visualitzen zones aneurismàtiques a sins
Gran estructura quística amb fluxe sanguini turbulent que desplaça cerebel

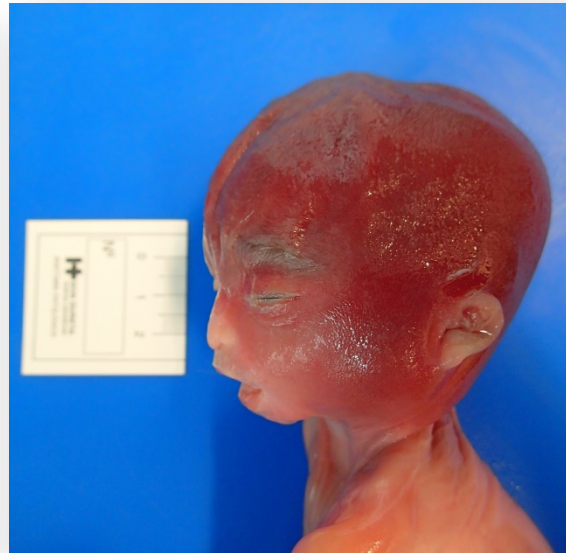
Dismorfia craneo-facial

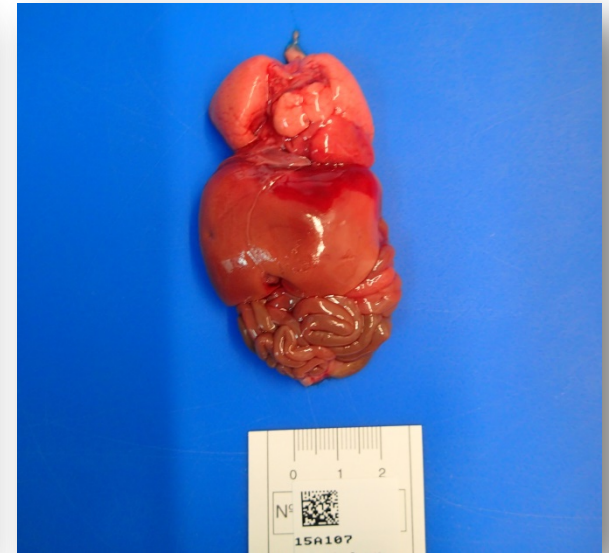
Pulmó dret bilobulat
